Journal section: Operative Dentistry and Endodontics
Publication Types: Research

Analysis of Surface Characteristics of ProTaper Universal and ProTaper Next Instruments by Scanning Electron Microscopy

Bennett J, Chung KH, Fong H, Johnson J, Paranjpe A. Analysis of Surface Characteristics of ProTaper Universal and ProTaper Next Instruments by Scanning Electron Microscopy. J Clin Exp Dent. 2017;9(7):e879-85.
<http://www.medicinaoral.com/odo/volumenes/v9i7/jcedv9i7p879.pdf>

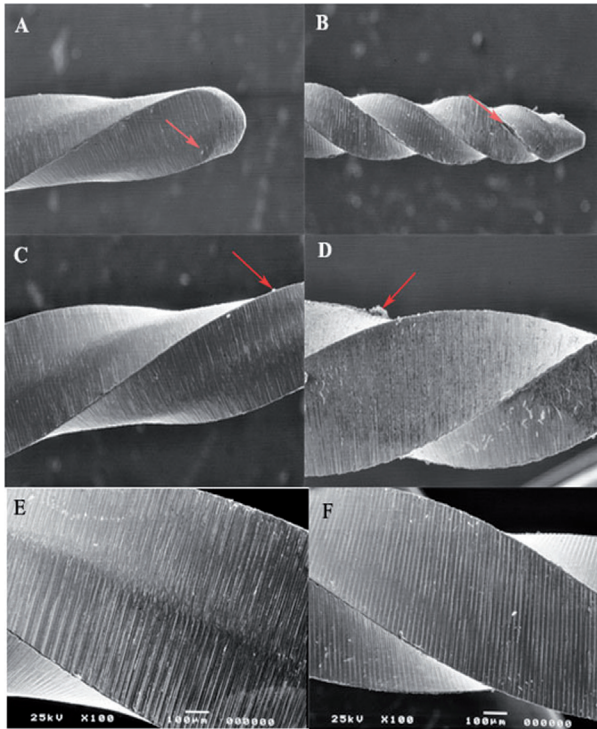
Fig. 1: SEM images of new files. SEM images of new PTU and PTN rotary files debris was seen on all new files of PTU (A and C) and on PTN files (B and D) as indicated by the red arrows. Images A and B were taken at 20X magnification and images C and D were taken at 100X magnification. Milling grooves are apparent on PTU files (E) and PTN files (F).

Morphometric changes such as the presence of machining grooves, metal flash, and debris could be visualized by stereomicroscopy and SEM in all the new files. Figure 1 is a representative image of the irregularities and debris in unused files as seen under the SEM. Figures 1A & C show the debris present on new PTU files and figures 1B & D demonstrated debris on new PTN files. The irregularities and debris were distributed randomly along the length of all files and most of these findings were only visible when viewed with SEM. The exact location, distribution, size and thickness of the material varied from one instrument to another, irrespective of size and taper. Most of the debris was found associated with deeper milling grooves and defects on the surface of the metal as seen in figure 1E (PTU) and 1F (PTN).

Early clinical studies with fractured instruments, is the number of times the files were used before fracture. New files of each type were examined by stereomicroscopy and SEM. All files showed the presence of irregularities and defects as seen in figure 1. All files showed varying amounts of machining grooves, metal flash, debris, and defects on cutting edges. These findings were consistent with other studies examining the surface of new files by SEM (25). The presence of surface defects appeared to be very important in the initiation of the fracture process of the used files. Fractographic analysis showed the presence of these defects to be associated with the initiation site of fatigue in all the files that fractured in the extracted teeth (Fig. 2). These defects act as weak points where stress is concentrated in the file, leaving the alloy more susceptible to fatigue and ultimately leading to crack propagation as stress continues (19). Next, one file from each group was made to fracture due to cyclic fatigue. An example of a PTU F3 file fractured by cyclic fatigue can be seen in figure 3A and the PTN X3 can be seen in figure 3B. Both figures demonstrate the beginning of the fracture at the inclusion where it progresses to voids within the body of the alloy. Then past this point is a fast fracture under load, represented by the signs of ductile fracture. Notable there were presence of small voids distributed throughout the bulk of the material within the body of the alloy (Fig. 3A,B). These findings were also observed in other studies (21). Porosities or voids could be visualized on the fractured surfaces of the files (Fig. 4). Porosities in nickel- titanium compacts can be from different sources including the Kirkendall effect, alloying effect, and a liquid capillary effect (26). Ounsi *et al.* (21) proposed that these voids were due to the Kirkendall effect. The Kirkendall effect is where the diffusion of nickel atoms into titanium is much faster than that of titanium atoms in the opposite direction, creating unbalanced mass transports leading to the formation of voids in the original nickel side of the alloy (26). Pirani *et al.* proposed that the voids might be caused by inclusions within the alloy grains and grain boundaries that may fracture or debond under an applied load (22).

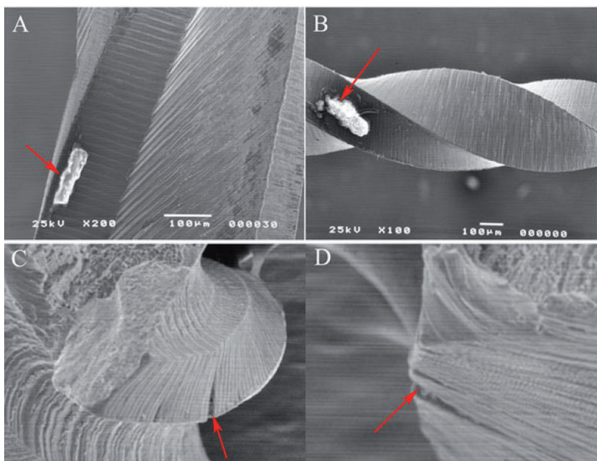
Fig. 2: SEM images of used and sterilized PTU and PTN rotary files. Debris was seen both file types PTU (A) and PTN (B). Figures 2C and 2D show crack formation and initiation of fractures in the PTU and PTN respectively.

Surface analysis of the files that were subjected to instrumentation and sterilization procedures, was performed by stereomicroscopy. The files appeared to have minimal morphological changes except the files that were bent, unwound, or fractured (data not shown). However, the SEM images showed a variety of differences in the files after they had been used in the extracted teeth. Figure 2 shows the SEM images demonstrating organic debris, metal flash, and crack formation and initiation of fractures for both PTU (Figures 2A & C) and PTN (Figures 2B & D). Crack origins were typically seen associated with manufacturing defects near the surface of the metal. Figures 2C and 2D are representative images of a crack initiation sites for both files.

An interesting finding was the frequency of the presence of remaining organic debris on the surface of the rotary files even after thorough ultrasonic cleaning and autoclaving (Fig. 2A,B). This finding was in accordance with previous studies where dentin debris was found adhering to the file surface after use and cleaning (18,20,30). It is suspected that the organic debris adheres to and remains on the file due to mechanical retention within irregularities both from manufacturing flaws and defects created during instrumentation. It can be assumed that these dental chips and other debris from root canal preparation *in vivo* will remain after extensive ultrasonic cleaning and autoclaving. This remaining debris has implications that should be studied further. Alapati *et al.* proposed that embedded dentin deposits cause a wedging action within machining cracks and may lead to their propagation resulting in instrument distortion and failure (18). Another concern is the potential exchange of organic debris between patients. This debris is assumed to be sterile after autoclaving, but its presence may be a source of antigens, infecting agents, or nonspecific irritants (31). Another study has demonstrated that prions can be present in human dental pulp tissue and there may be a risk of infection by contaminated files (32). However, research is lacking on the risk of infection and further studies should be pursued before a recommendation can be made.

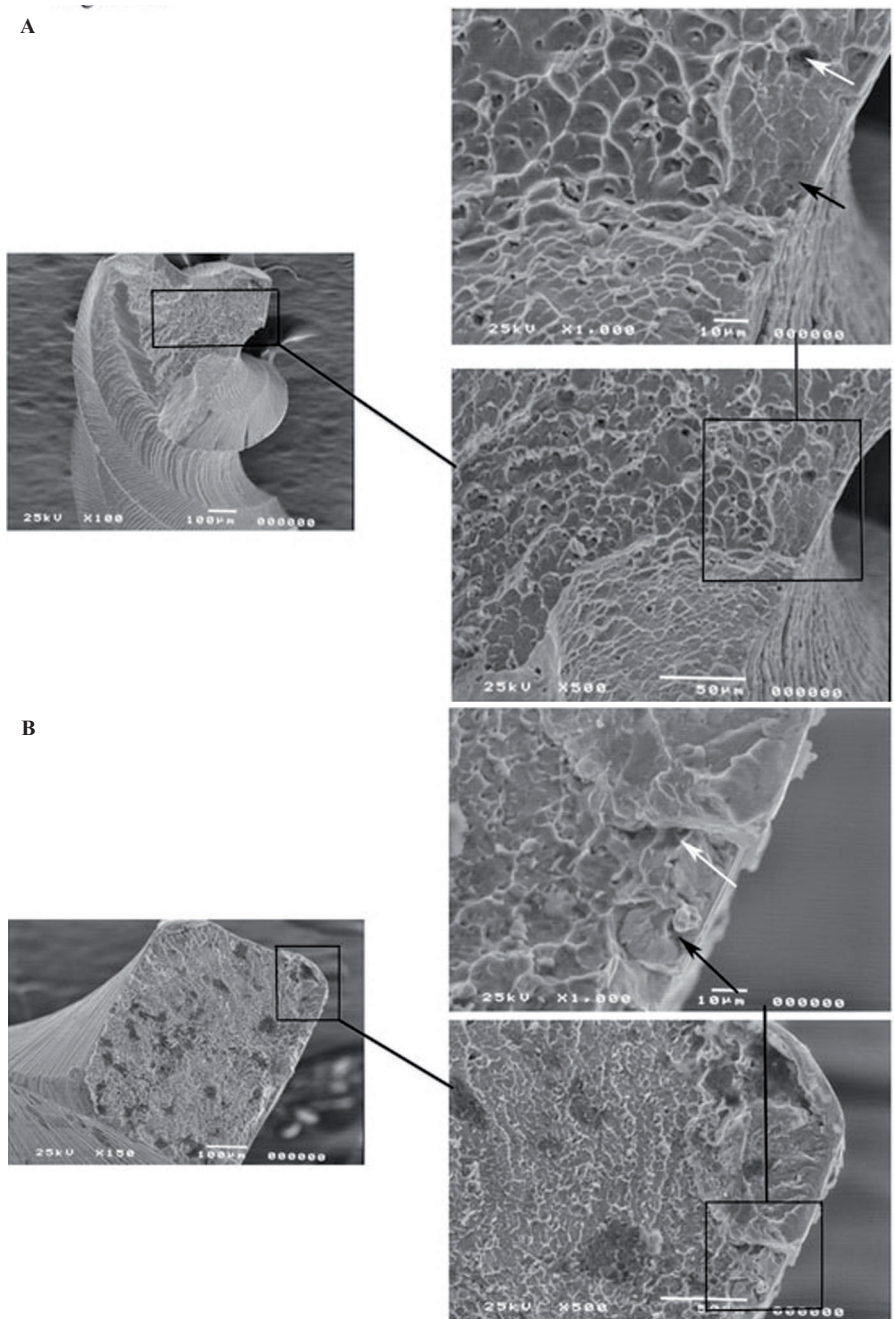
Files from both groups (F3 and X3 files) were subjected to fractures due to cyclic fatigue as described previously (13). The fractured files examined by stereomicroscopy showed signs of both torsional and flexural fracture, according to classification by Sattapan *et al.* (14). However, when these fractured surfaces were examined under the SEM, they demonstrated a ductile fracture associated with a defect within the file. Figures 3A and B are views of the fractured surfaces of an F3 PTU and an X3

Fig. 3: SEM images of files fractured by cyclic fatigue. Figure 3A is an SEM image of a PTU F3 file fractured and Figure 3B is an SEM image of a PTN X3 file fractured by cyclic fatigue. The sub-figures show a magnified image of one part of the fracture surface which demonstrates the beginning of the fracture at this inclusion (black arrows) where it progresses to voids within the body of the alloy (white arrows). Then past this point we can see a fast fracture under load, represented by the signs of ductile fracture.

PTN file respectively. The sub-figures show a magnified image of one part of the fracture surface. As seen from the figure both file types showed the beginning of the fracture at the inclusions (black arrows) from where it progressed to voids (white arrows) within the body of the alloy. The start of the ductile fracture was associated

with larger voids or fractures within the metal. Figure 4 is another representative image of the fractured surface of a file PTN X3 demonstrating inclusions and microvoids of varying sizes that were also seen distributed throughout the fractured surfaces of the files. Similar voids and inclusions were seen in the PTU F3 file group.

The inclusions within NiTi alloy are assumed to be titanium carbonitrides and NiTi oxides formed during the vacuum melting and casting in graphite cubicles (22,27) (Fig. 4). This process causes slight carbon contamination in the melt, forming the oxide impurities that appear evenly distributed within the NiTi matrix (27). The concentration and distribution of the inclusions has been proposed as a method of assessing the metallurgical quality of the NiTi alloy produced by different manufacturers of rotary instruments (28). However, there was no apparent difference in the distribution of inclusions between PTU and PTN rotary files. The voids and inclusions were distributed evenly within dimples associated with ductile fracture in all samples (Fig. 3). This is an

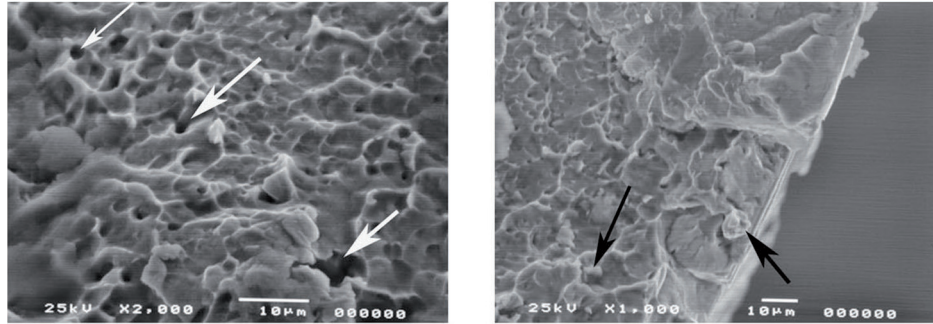
Fig. 4: A representative image of the fractured surface of a file PTN X3. The figure demonstrates microvoids (white arrows) and inclusions (black arrow) of varying sizes that were also seen distributed throughout the fracture surfaces of the files.
