Journal section: *Prosthetic Dentistry*Publication Types: *Research*

Bond strength of lithium disilicate after cleaning methods of the remaining hydrofluoric acid

dos Santos DM, Bitencourt SB, da Silva EVF, Matos AO, Benez GC, Rangel EC, Pesqueira AA, Bar o VAR, Goiato MC. Bond strength of lithium disilicate after cleaning methods of the remaining hydrofluoric acid. J Clin Exp Dent. 2020;12(2):e103-7.

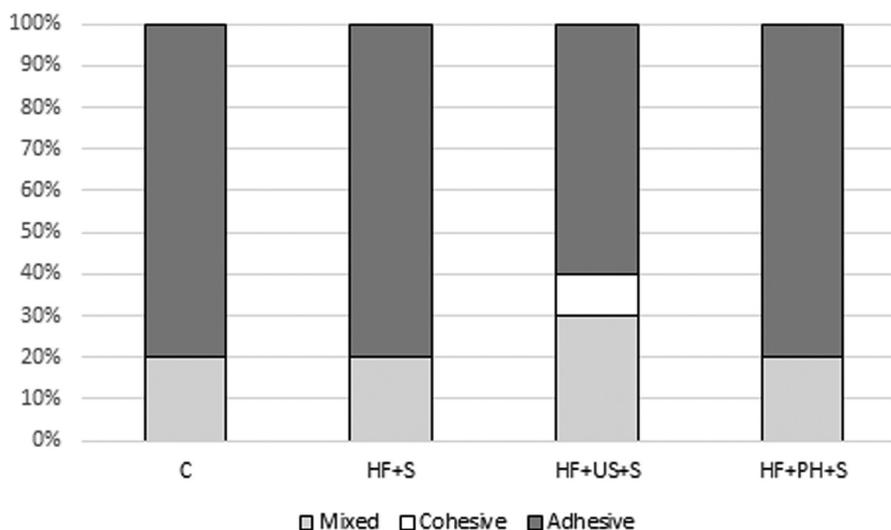
Fig. 1: Percentage distribution of bond failure types (adhesive, cohesive, or mixed) between ceramic and resin cement in groups analyzed. Group C: no surface treatment; Group HF+S: 5% hydrofluoric acid + silanization; Group HF+US+S: 5% hydrofluoric acid + ultrasound + silanization; Group HF+PH+S: 5% hydrofluoric acid + 37% phosphoric acid gel + silanization.

Figure 1 illustrates the percentage distribution of bond failures between the ceramic and the resin cement for different surface treatments analyzed. The type of surface treatment did not influence the failure mode (Chi-squared test, $p=.713$).

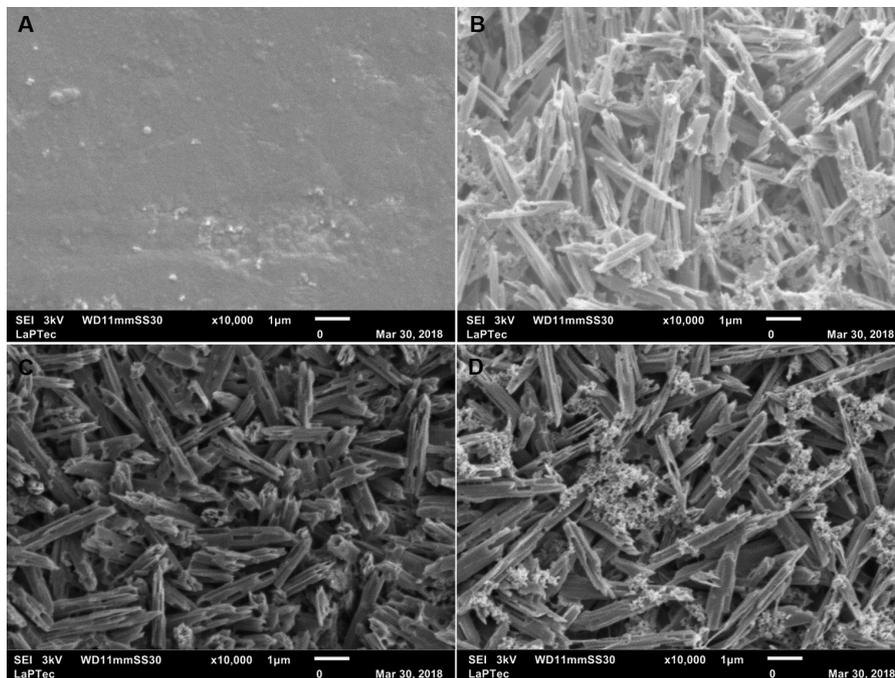
Fig. 2: Representative SEM micrographs (10,000x) of ceramic specimens in periods: (A) T0 (specimen without treatment); (B) T1 (after treatment with hydrofluoric acid); (C) T2 (after treatment with hydrofluoric acid followed by cleaning with ultrasound); and (D) T3 (after treatment with hydrofluoric acid followed by cleaning with 37% phosphoric acid).

According to Figure 2 (T1 and T3), the dissolution of the glassy phase was observed with the exposition of lithium disilicate crystals, surrounded by fluorosilicate precipitates. In the period T2, the presence of exposed lithium disilicate crystals was observed. Through the EDS spectrum, high percentages of carbon

The use of phosphoric acid did not completely remove the precipitates of fluorine deposited on the specimens' surface, which was verified by the SEM images (Fig. 2D) and by the EDS test, which detected the presence of F on the surface (Fig. 3). Despite no significant statistical difference was verified, the presence of this sub-product, even in a small percentage could have influenced the SBS of the group HF+PH+S, which was smaller than the group HF+US+S (Table 2).

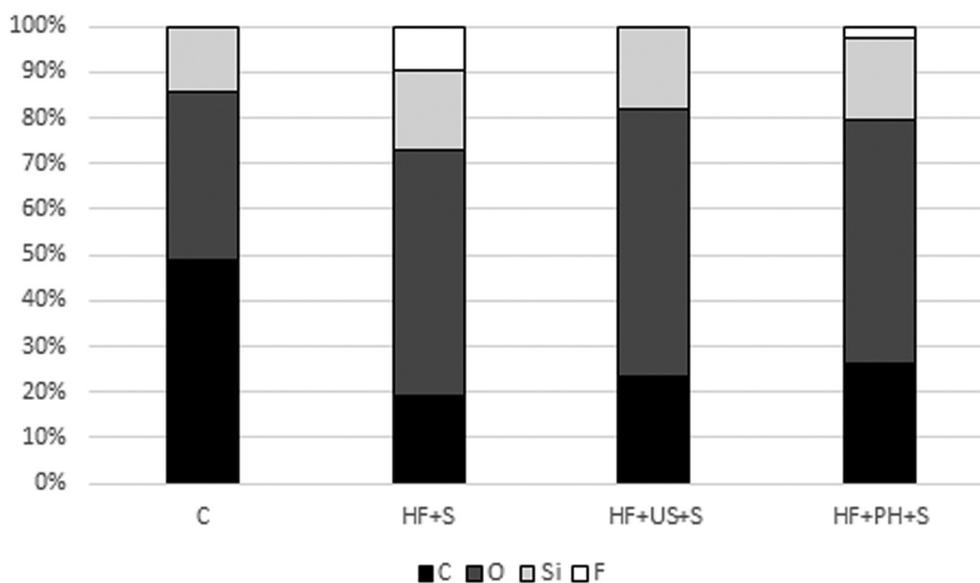
Fig. 3: Percentage distribution of elements identified in the EDS of ceramic specimens analyzed in different stages. Group C: no surface treatment; Group HF+S: 5% hydrofluoric acid + silanization; Group HF+US+S: 5% hydrofluoric acid + ultrasound + silanization; Group HF+PH+S: 5% hydrofluoric acid + 37% phosphoric acid gel + silanization.

(C) and oxygen (O), and smaller percentages of silicon (Si) can be observed for all the periods evaluated (Fig. 3). Fluorine (F) was verified only in the T1 and T3 periods.
