Journal section: Operative Dentistry and Endodontics
Publication Types: Research

The Effect of surface topographical changes of two different surface treatments rotary instrument

Qaed NA, Mourshed BD, Al-Shamiri HM, Alaizari N, Alhamdah SS.
The Effect of surface topographical changes of two different surface treatments rotary instrument. J Clin Exp Dent. 2018;10(1):e49-53.
<http://www.medicinaoral.com/odo/volumenes/v10i1/jcedv10i1p49.pdf>

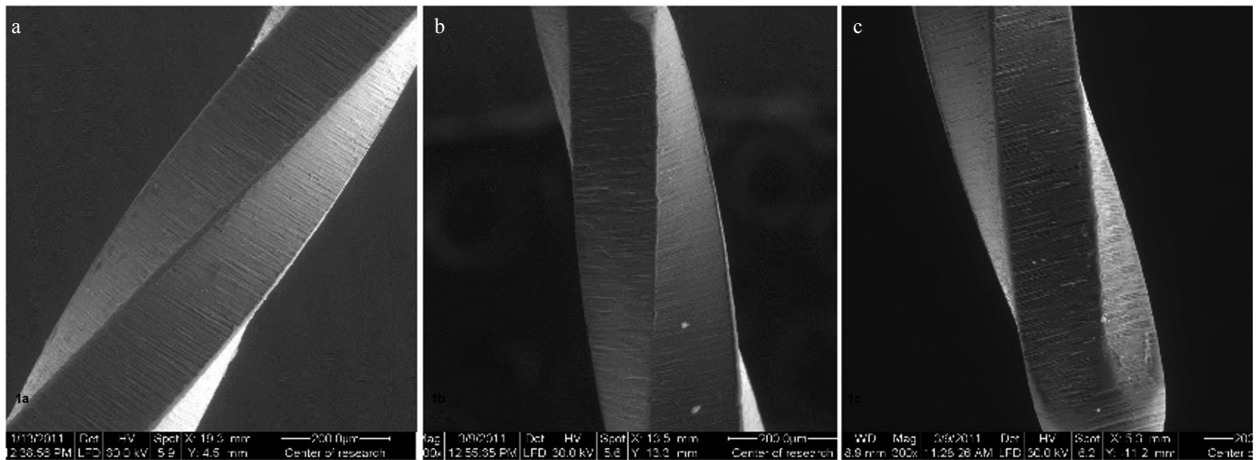
Fig. 1: (a): Scanning electron micrograph of unused AlphaKite file (subgroup A1) with marked machining grooves (X300-Magnification) (b): Scanning electron micrograph of AlphaKite file after (subgroup A2) presenting disruption and blunting of cutting edges and deepening of the machining groove (X300 magnification) (c): Scanning electron micrograph of AlphaKite file (subgroup A3) showing microcracks (white arrow) and deepening of the the machining grooves with metal stripping along the cutting edge (black arrow) (X300 magnification).

On examining the AlphaKite files subgroup A1, the unused group, under ESEM, revealed gross machining grooves on their surface with no pits, strips or disruption (Fig. 1a).

After three uses and one autoclave cycle, subgroup A2, scanning electron micrographs showed disruption of cutting edges that were also blunted and scraped with deepening of the machining grooves (Fig. 1b).

After nine uses and three sterilization cycles in autoclave, subgroup A3, the scanning electron micrographs showed microcracks and deepening of the machining grooves with metal stripping along the cutting edge (Fig. 1c). In this group also one of the instruments was fractured. The fractured surface under magnification (X 205) showed the classical signs of ductile fracture; plastic deformation with areas showing irregular dimples and concentric abrasion marks at the periphery with a fibrous appearance in the center (Fig. 2a).

Both AlphaKite and Rivo S NiTi files showed changes their cutting edges after 3 uses and one autoclave cycle. As shown in Fig. 1b AlphaKite files under the scanning

electron micrographs showed disruption of cutting edges that were blunted and scraped with deepening of the machining grooves while Revo-S files, the dulling and blunting of the cutting edges was predominant (Fig. 2c).

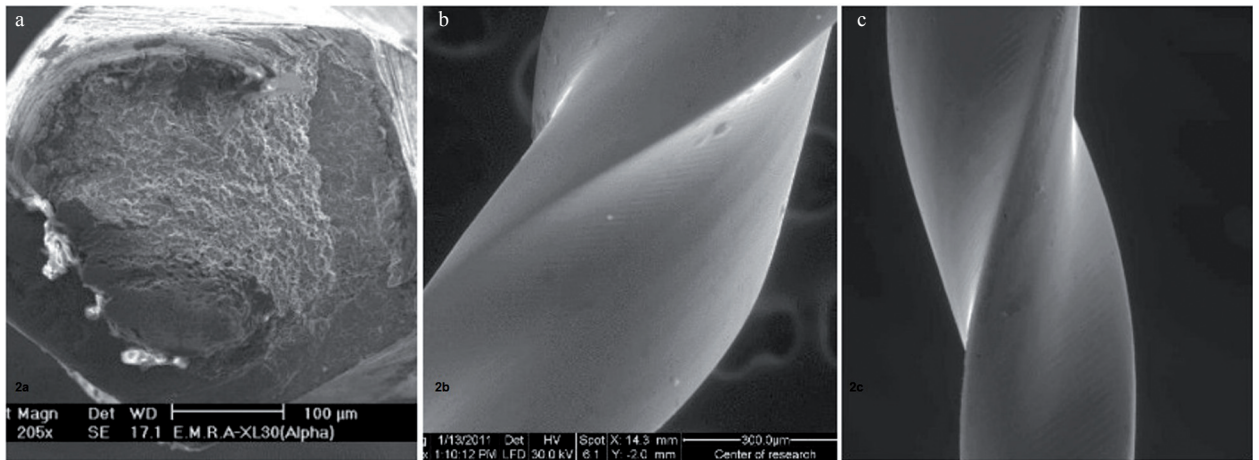
Fig. 2: (a): Scanning electron micrograph of AlphaKite file (subgroup A3) showing macroscopic plastic deformation at the fracture site (black arrow). Signs of ductile fracture, and irregular dimples that resembles a fibrous structure (white arrow) (X205 magnification) (b): Scanning electron micrograph of unused Revo-S file (subgroup B1) with smooth surface and slight machining groove (X300 Magnification) (c): Scanning electron micrograph of Revo-S file (subgroup B2) showing dulling and scrapping of the cutting edges (X300 magnification).

By examining Revo-S files, the scanning electron micrographs of unused files, subgroup B1, showed a smoother surface with few machining grooves (Fig. 2b).

On examining Revo-S files after three uses and one sterilization cycle, subgroup B2, dulling and blunting of the cutting edges was predominant (Fig. 2c).

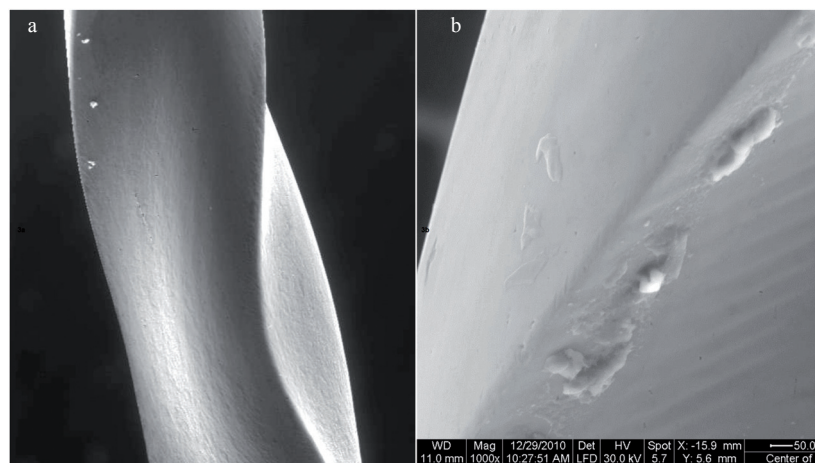
Fig. 3: (a): Scanning electron micrograph of Revo-S file (subgroup B3) showing unwinding (x200 magnification) (b): Scanning electron micrograph of Revo-S file (subgroup B3) showing metal flakes on the file surface (X1000 magnification).

After nine uses and three sterilization cycles, subgroup B3, files showed plastic deformation in the form of unwinding of the flutes, disruption in the surface with metal flakes (Fig. 3a,b).

On the other hand, the surface changes of the Revo-S files after 9 uses were mainly in the form of plastic deformation represented by unwinding of the flutes and blunting or disruption of the cutting edges with increased pitting. This enhanced performance could be explained by the fact that the Revo-S has small triangular cross section with decreased metal core besides the effect of smoothening obtained by electropolishing thus reducing the stress applied on the surface of instruments (25). In addition, by removing the surface layer of the instrument by electropolishing this may potentially eliminate residual stresses which might explain the absence of any fractured Revo-S file (15).
