Influence of composite resin core buildup translucency on the accuracy of an anterior CAD-CAM bridge fabricated with a digital impression

Received: 10/10/2024 Accepted: 29/01/2025 Tran NC, Nguyen NDM, Huynh NCN, Tran TTN, Hoang HT, Wang DH, Hsu ML. Influence of composite resin core buildup translucency on the accuracy of an anterior CAD-CAM bridge fabricated with a digital impression. J Clin Exp Dent. 2025;17(4):e366-73.

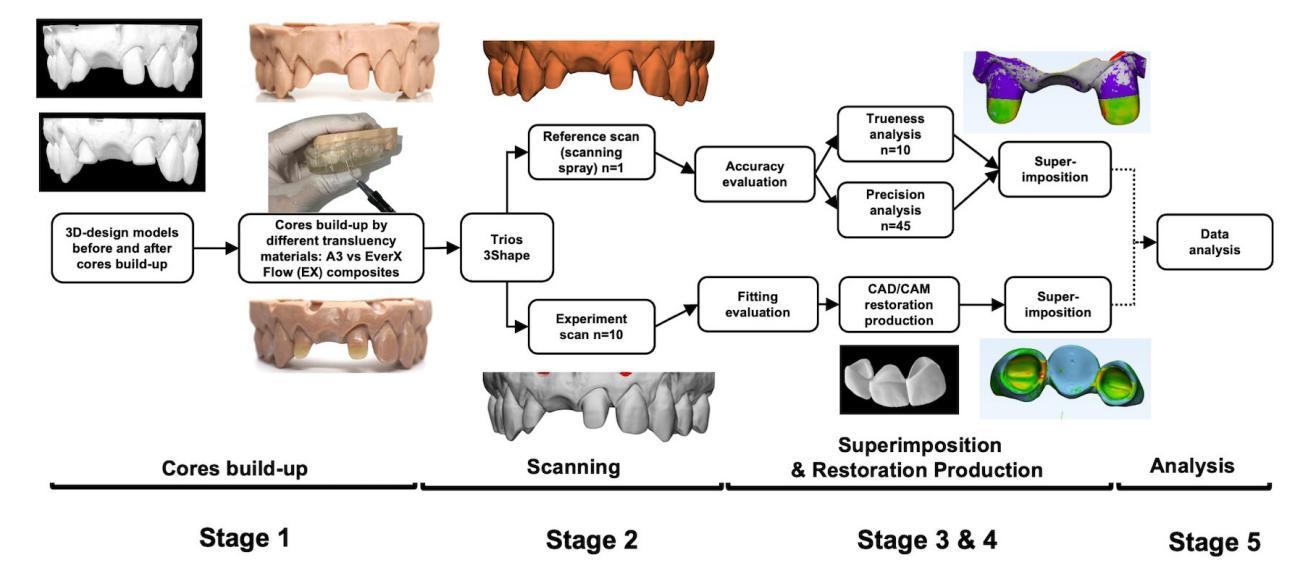
Fig. 1: Conceptual framework of the study. The workflow was divided into 5 main stages: 1. core build-up, 2. scanning, 3. image superimpose, 4. CAD/CAM restoration production and 5. analysis.

In this study, we investigated the effect of two different composites used for core build up in the fabrication of a 3-unit CAD/CAM bridge on anterior teeth and detected the fitting error within the clinical acceptable threshold of final restoration. Fig. 1 shows the conceptual framework of the study. The workflow was divided into 5 main stages: 1. Core build-up, 2. Scanning, 3. Image superimposition, 4. CAD/CAM restoration production and 5. Analysis of accuracy.

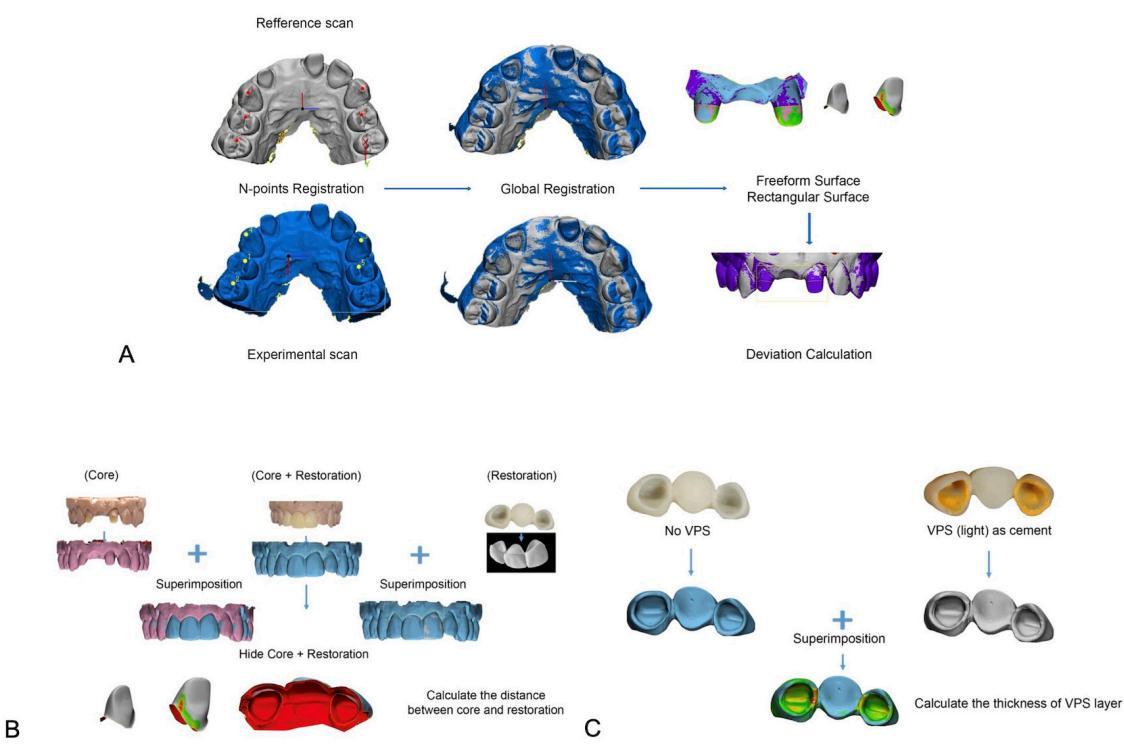
Fig. 2: Superimposition and fitting error checks. A, Superimposition procedure. B, Fitting error check by calculation of gaps between cores and restorations. C, Fitting error check by calculation of the thickness of VPS layer.

For 3D superimposition and measurement, 3-Matic Research (version 21.0, Materialise N.V.,) was utilized. A two-step alignment procedure was used to superimpose each pair of scan data (Fig. 2a). First, three reference along with a color scale, where the blue area represents the outward or positive deviation of the IOS scan, and the red area represents the negative or inward deviation. Each IOS scan was superimposed with the reference scan (n=10) to calculate the trueness. Each IOS scan file was aligned with other IOS scans in the same group (n=45) to compute the precision. These parameters were noted: Mean (μ m): the average distance in 3D pictures of two scans; max (μ m): the greatest variance; Mean (0.05, max) (μ m): A 0.05mm (50 μ m) criterion indicates an unacceptable mean deviation; Distribution ratio of unaccepted/total elements (%): percentage of unaccepted locations relative to total deviating locations.

We performed fitting error check by calculation of gaps between cores and restorations (Fig. 2c). Cores only, cores with restorations and restorations only were scanned separately and then superimposed. The scanning image of core with restoration was removed to calculate the gaps between cores and restorations. We also checked the fitting error by using low viscosity Polyvinylsiloxane Impression Materials (PVS) (Fig. 2c) to simulate the cement material. The restorations were adhered to the isolated cores using PVS then removed. The models with composite abutments and restorations with PVS were scanned separately and then superimposed. We calculated the thickness of internal gaps (PVS) to determine the fitting error.

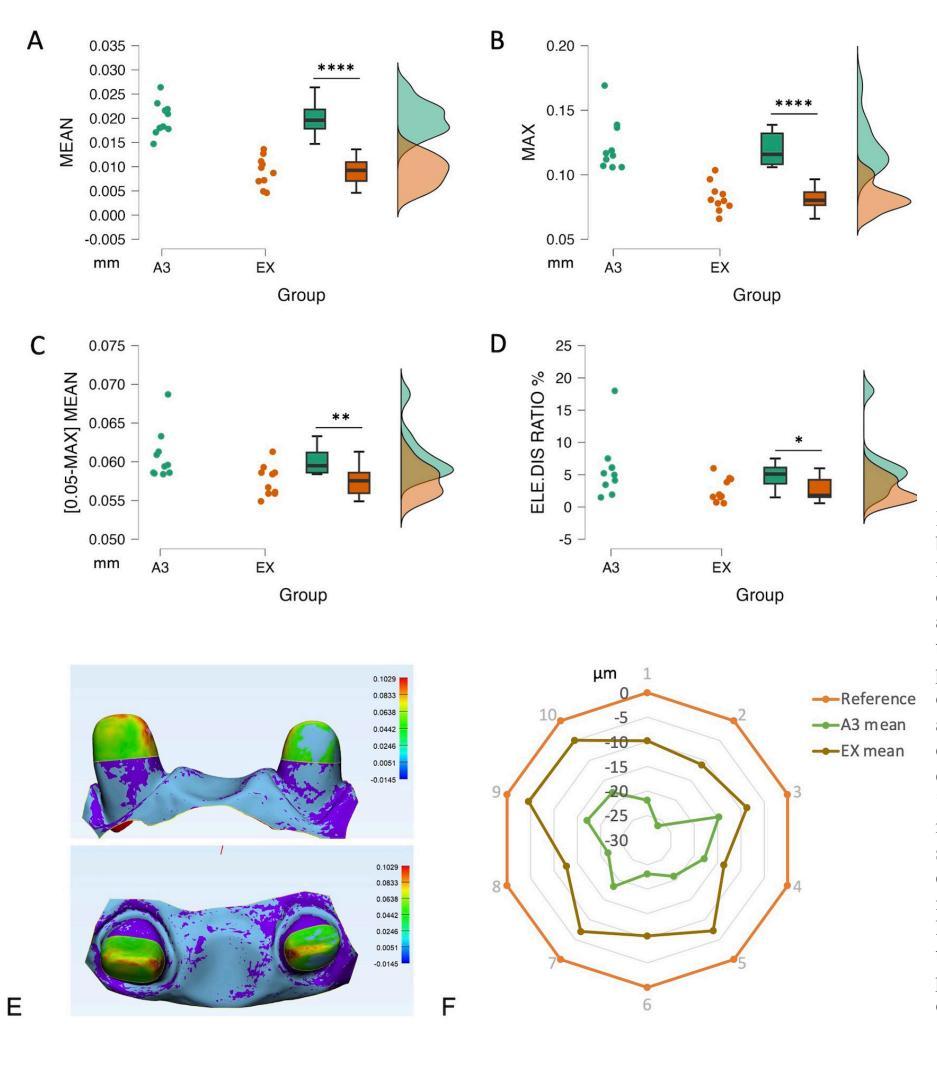
Fig. 3: The trueness of IOS affected by resin composite translucency. (a) Mean and (b) Deviations of 2 groups of composites. (c) Mean deviations and (d) Ratio of point locating out of the acceptable threshold of 2 composites considering the cut-off value of deviations as 50µm for clinical acceptability. Data presented by dots, median and 75th-25th percentile and histogram; * P<0.05, ** P<0.01, **** P<0.0001. (e) The result of superimposition reference scan and experimental scan data of composite A3, deviation ladder in mm. (f) Two composite core groups had a scaled-down image compared to the reference data. Lines were presented as the mean of deviation of each group.

After 10 times of registration in both groups to the respective reference data, the results indicated that there is a scale deviation of IOS data toward the references. The results showed that the core build-up scan data from EX composite had higher trueness value than the one from A3 composite. More specifically, mean and max distortion was higher in A3 group (20 and 120µm respectively), and EX (9 and 80µm respectively) (Fig. 3a,b respectively). Considering the deviations over 50µm as clinical unacceptability, the mean deviation of (0.05max) and the percentage of the unaccepted deviated area were collected and analyzed. The analysis elucidated that A3 composite created a higher deviation in the range of clinical unacceptability than EX composite. The percentage of unacceptable areas over the total surface showed that almost 6% of the area of A3 data deviated further to the acceptable range, while this value in EX was around 2% (Fig. 3c,d).

The registration results were illustrated by a color scale. In the A3 composite groups, the deviation area stayed mostly on the incisal edge, mesial and distal ridge of the abutment (Fig. 3e). The trueness results of both groups were shown by the chart below (Fig. 3f). The orange outline represented the reference data whereas the experimental data included the brown line (EX composite) and the green line (A3 composite). The more centered the experimental lines are, the higher deviation is. The brown line (EX) stayed closest to the referenced line also meant that EX had the better trueness.

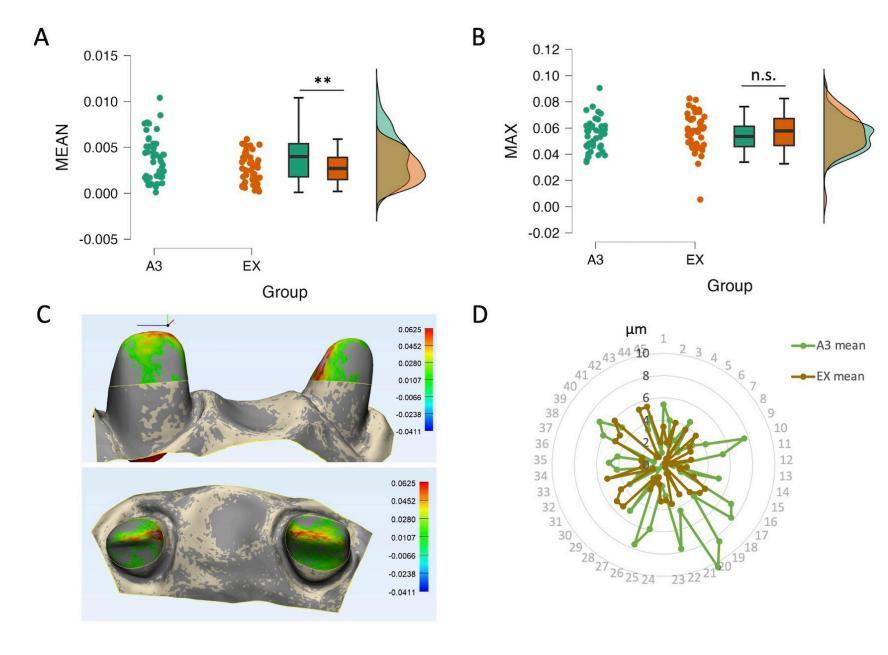
Fig. 4: The precision of IOS affected by resin composite translucency. (a) Mean and (b) Max deviations of 2 composites. (c) The difference between 2 scans of A3 group (deviation ladder in mm) by superimposition. (d) The circle lines represented the precision of the scan data between groups. Lines presented as the mean of deviation of each group. Data (a, b) were presented by dots, median and 75th-25th percentile and histogram; ** P < 0.01, n.s. nonsignificant.

In general, the precision of IOS scan data was higher in EX than A3 groups. Means of deviation were 4μ m in A3 and 3μ m for EX (Fig. 4a). There was no significant difference in max of deviation (Fig. 4b). Meanwhile, composite A3 which has higher translucency tended to create reduction especially in the incisal edge (Fig. 4c). Looking at the dispersion of the precision values, we can see that the scan data of EX is more homogeneous than A3 group (Fig. 4d). These results suggested that composite EX had the best performance in terms of precision.

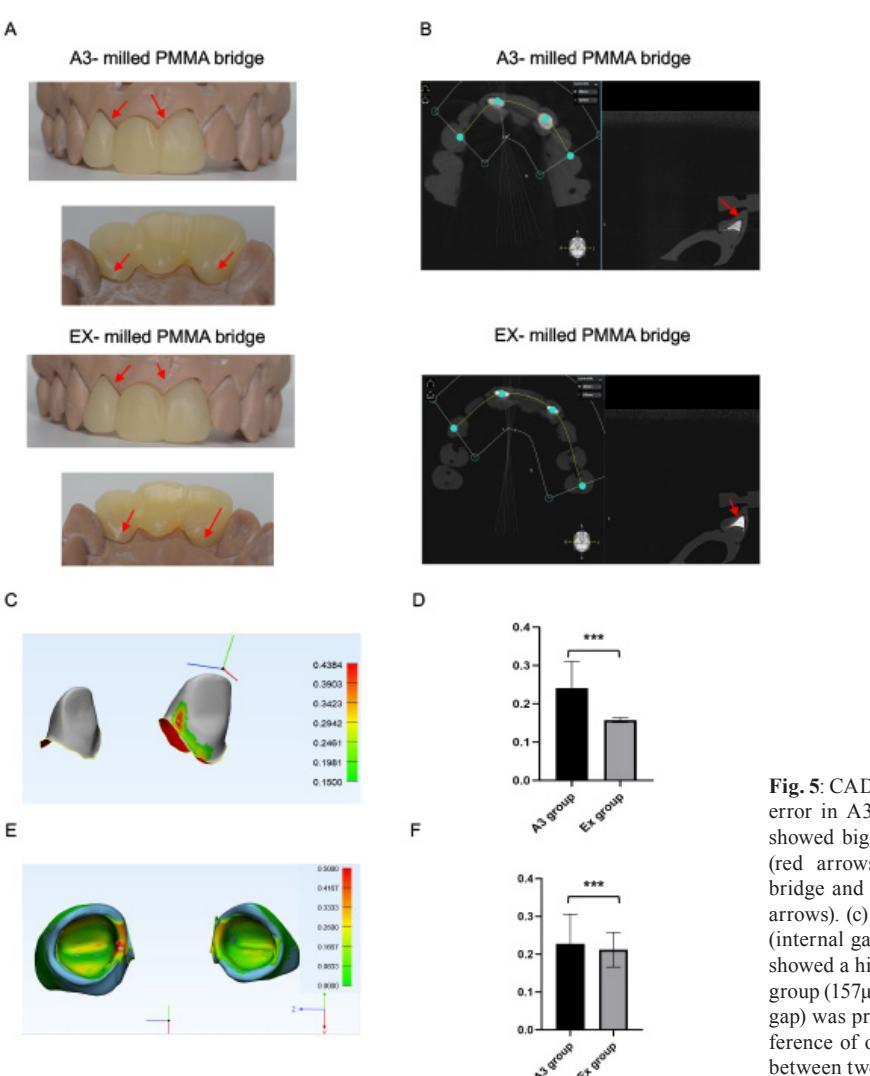
Fig. 5: CAD/CAM bridge restorations resulted in fitting error in A3 group. (a) The A3-milled PMMA bridge showed bigger marginal gap with abutments than EX (red arrows). (b) The gap between milled-PMMA bridge and abutments of A3 & EX on CBCT file (red arrows). (c) The distance between core and restoration (internal gap) presented by a color scale. (d) A3 group showed a higher mean of internal gap (240µm) than Ex group (157µm). (e) The thickness of VPS layer (internal gap) was presented by a color scale. (f) Significant difference of over clinical acceptable threshold (150 µm) between two groups A3 (227µm). and Ex (212µm).

We produced bridges of one experiment scan for each A3 and EX groups by milled PMMA and checked the fitting to core build-up abutments. The group of composite A3 showed a bigger marginal gap than the composite EX (Fig. 5a). These fitting results were observed more clearly on the CBCT view, the bridge manufactured from the groups of composite EX performed a better margin adaptation than the composite A3 (Fig. 5b).

After registration the abutments scan with and without the PMMA bridge, the distance between abutments and bridge was calculated and analyzed (Fig. 5c). The mean internal gap was seen higher on the abutment built up with A3 composite group (240 μ m), which was 157 μ m for EX composite group (Fig. 5d). Considering 150um as the standard threshold of cement gap, we calculated the area that shot over 150 μ m as the clinically unacceptable zone. There was a significant difference in terms of percentage of unacceptable zone in A3 group (5,38%) compared to EX group (0,82%).

With the use of PVS materials as the cement layer, the thickness of PVS layer (internal gap) was calculated by superimposing the restoration scan with and without abutment (Fig. 5e). A3 group showed a higher internal gap (227μ m) than Ex group (212μ m) (Fig. 5f). There was a significant difference in terms of percentage of unacceptable zone in A3 group (10.3%) compared to EX group (4.8%), (Tables 1-3).
