Journal section: Prosthetic Dentistry Publication Types: Case Report doi:10.4317/jced.54358 http://dx.doi.org/10.4317/jced.54358

# Orthodontics and veneers to restore the anterior guidance. A minimally invasive approach

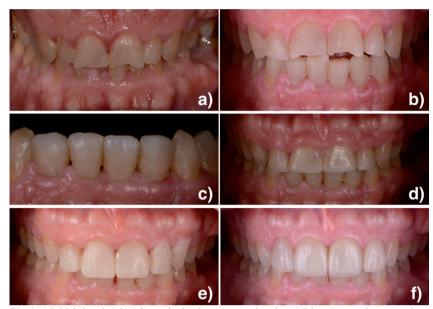
A 43-year-old male patient was referred to the dental clinic. Clinically, tooth wear was only diagnosed in the anterior region due to an inadequate anterior guidance, thus a consequent reduction of the occlusal vertical dimension (Fig. 1a).

**Fig. 1:** a) Initial situation. b) After orthodontic treatment situation. c) Direct composite restorations from 32 to 42. d) Direct composite restorations from 12 to 22. e) Mock-up. f) Final situation.

In the first phase, orthodontic treatment was carried out. Following Dahl's principle, resin attachments (Mini-Mold bite opening kit, G&H Orthodontics, Franklin, Indiana, EEUU) were placed in the upper canines (Fig. 2b). These attachments allowed the extrusion of posterior teeth in order to increase occlusal vertical dimension. At the same time, anterior teeth were intruded in order to create space for the restorative material (Fig. 1b, Fig. 2c).

In the second phase, the restorative treatment was completed. Previously, a diagnostic wax-up was performed to define shape and form to assist the treatment planning. Mandibular incisors were restored by direct composite restorations with Ceram X (Dentsply Sirona, Konstanz, Germany) (Fig. 1c, Fig. 2d). Then, incisal lengthening with direct composite (Ceram X, Dentsply Sirona, Konstanz, Germany) was performed (Fig.1d). Due to the case characteristics, feldspathic ceramic veneers (Kuraray Noritake dental Inc, Japan) of minimum thickness were indicated for the four maxillary incisors. A mockup was prepared for the maxillary incisors (Fig. 1e). Its functionality and aesthetics were verified statically and dynamically. By using the mock-up technique, minimal preparations were made to ensure a minimally invasive technique (Fig. 2e). Afterwards, silicone impressions (Aquasil Ultra, Dentsply Sirona, Konstanz, Germany) were taken.

The final restorative phase was achieved by checking the restorations for any occlusal interference. Immediate final restorations can be observed in Figures 1f and 2f.

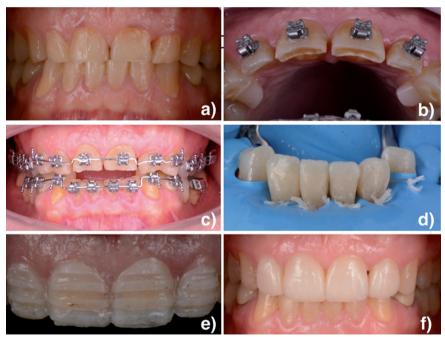
A 42-year-old male patient came to the dental clinic. He complained of discomfort caused by his worn anterior teeth. Clinical analysis showed tooth wear with dentine exposure and a reduction in clinical crown height. He presented an incisal edge-to-edge relationship (Fig. 2a). In both cases, anterior teeth were worn and the oclussal vertical dimension was reduced. After clinical examination, impressions of maxillary and mandible arches were taken with alginate to obtain preliminary casts. After thorough diagnosis and planning, a comprehensive treatment plan that incorporated all the wishes of the patient was devised. In both cases an interdisciplinary ortho-restorative treatment was carried out in order to ensure a minimally invasive treatment.

**Fig. 2:** a) Initial situation. b) Resin attachments. c) Orthodontic treatment. d) Direct composite restorations from 32 to 42. e) Preparation through the mock-up. f) Final situation.
